PROPERTY CONDITION ASSESSMENT
OF
WORLD TRADE CENTER PORTFOLIO

SUBGRADE

NEW YORK, NEW YORK

Re: Due Diligence Physical Condition Survey
World Trade Center
New York, New York

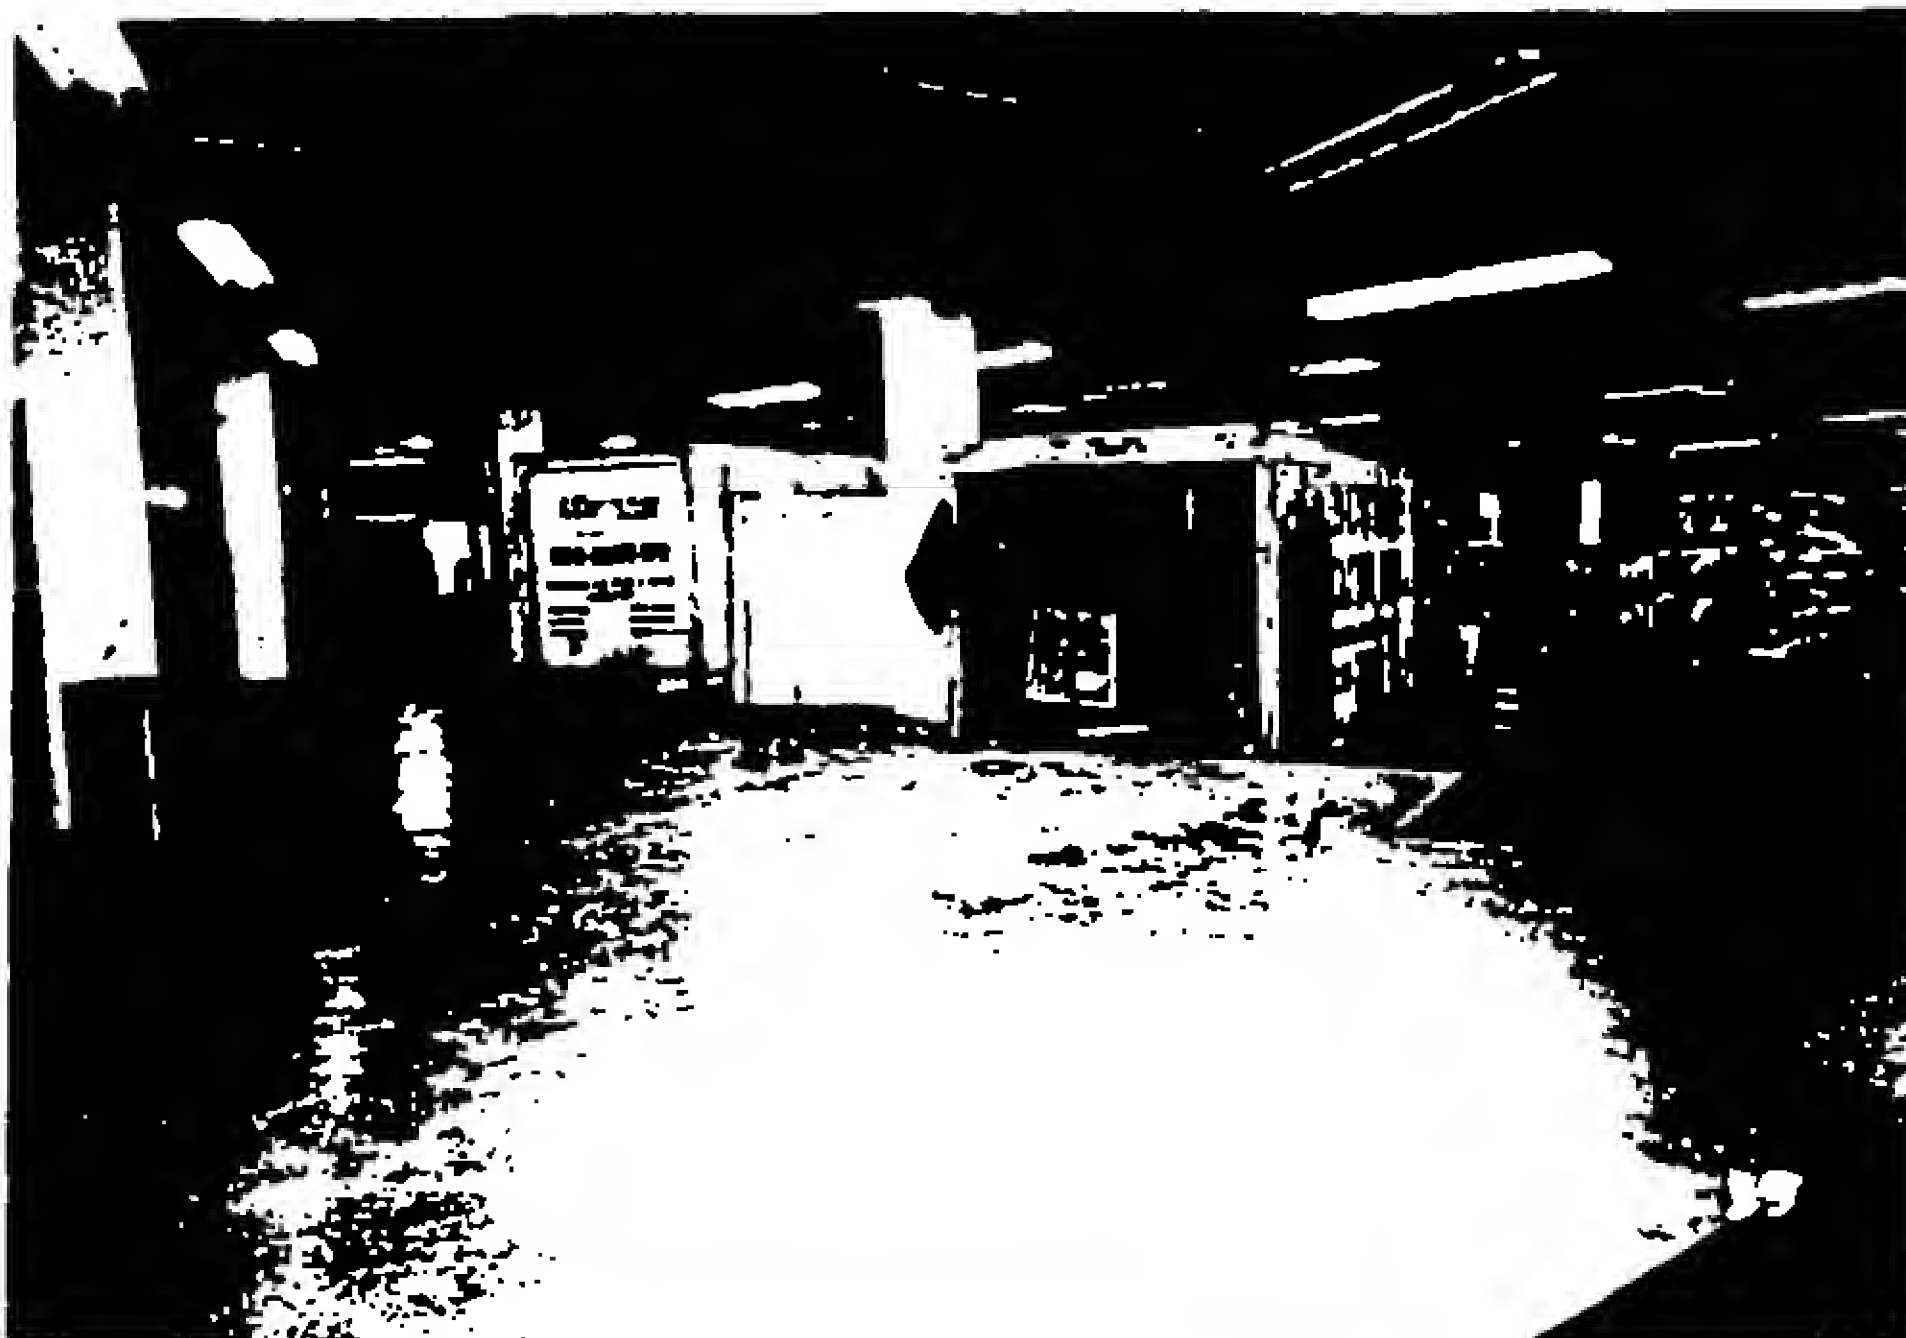
Photograph 10

Loading dock area

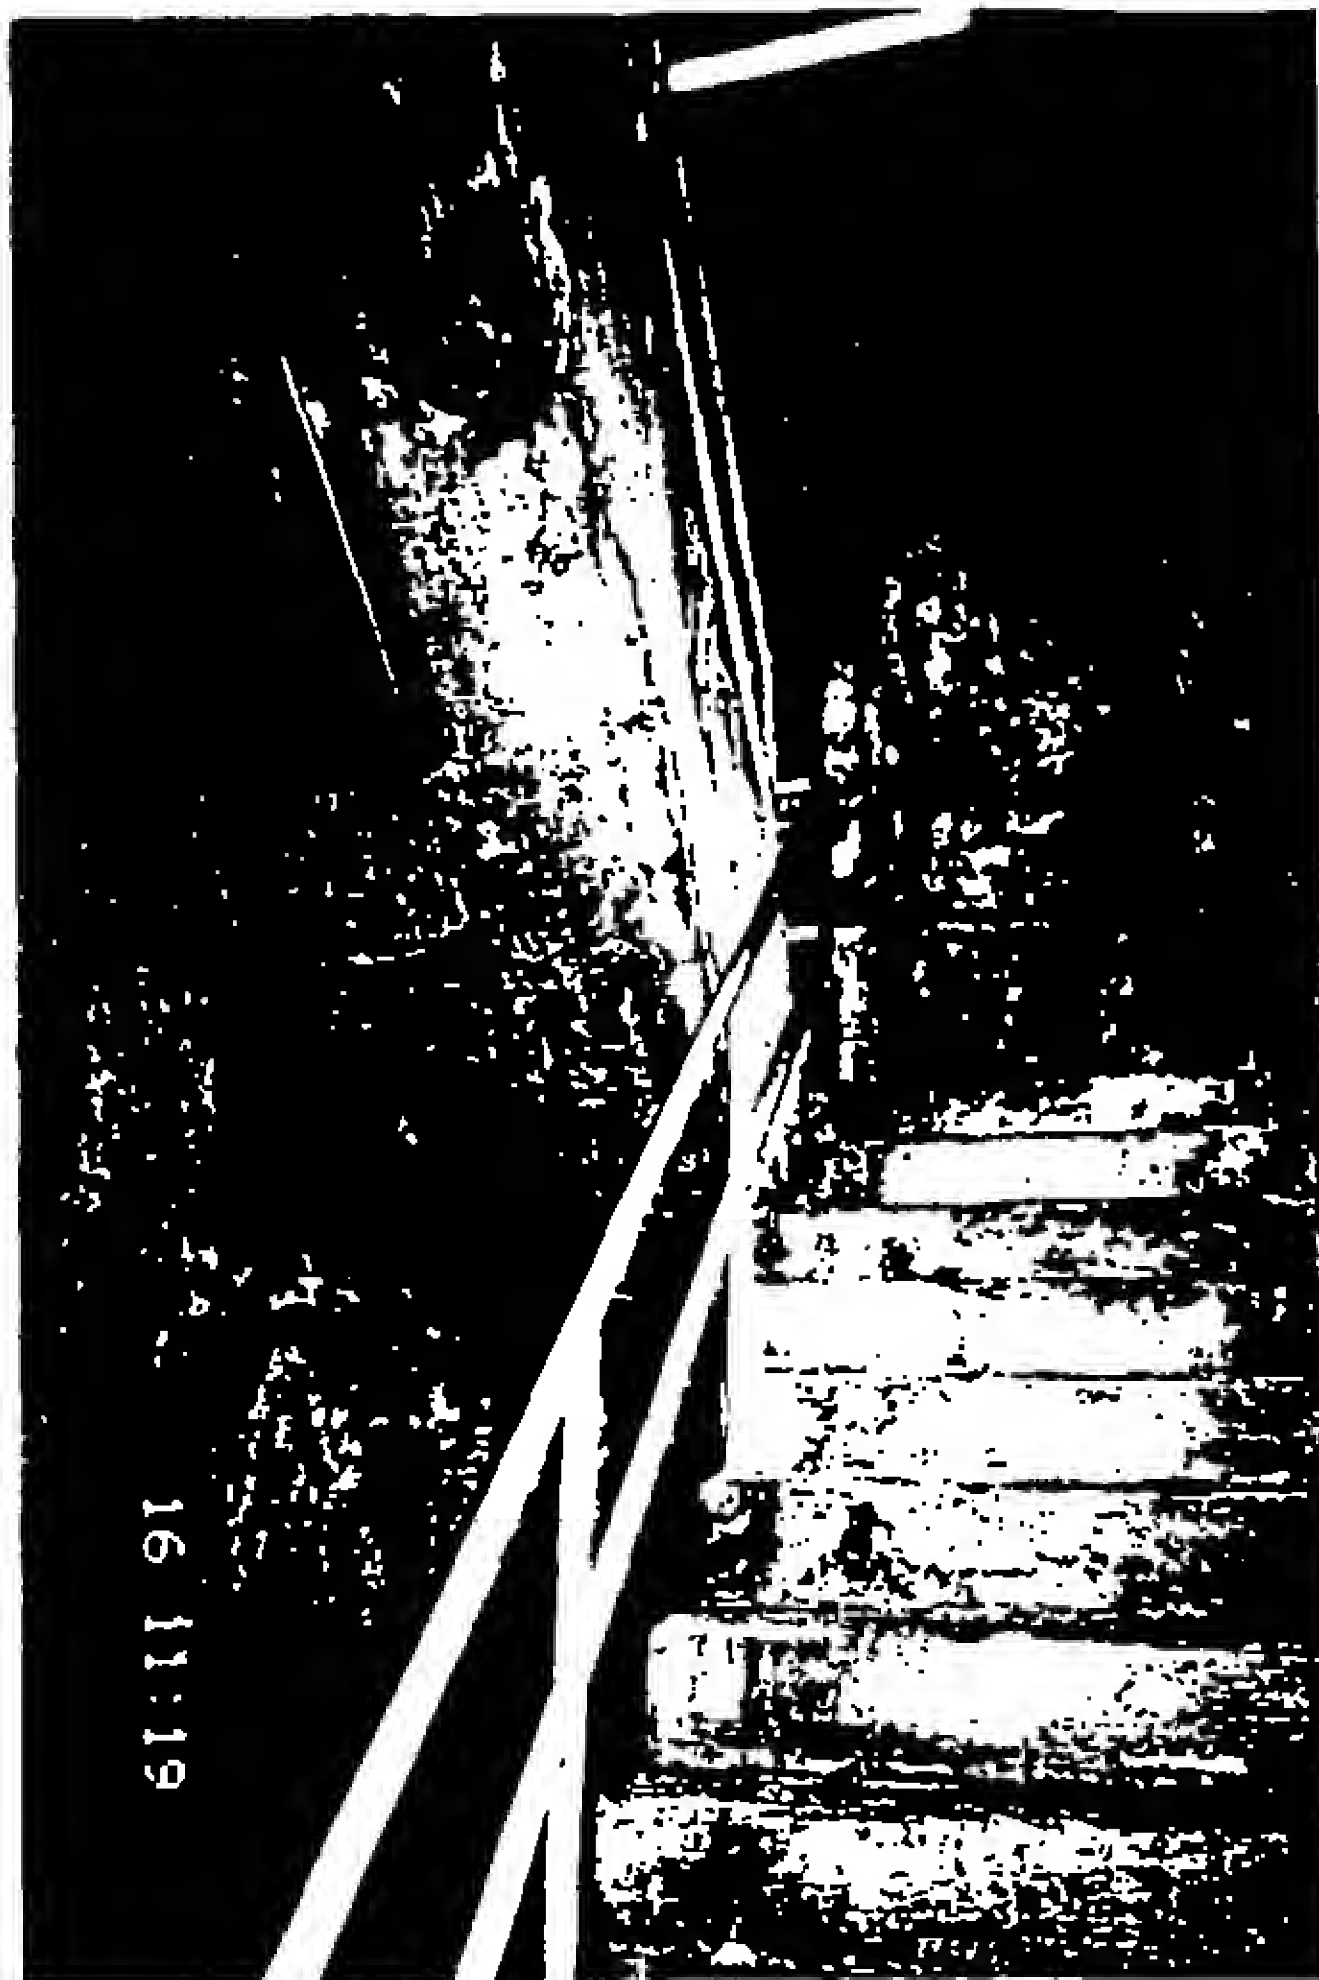
Photograph 21

Stair in projection
serves as PATH
emergency exit

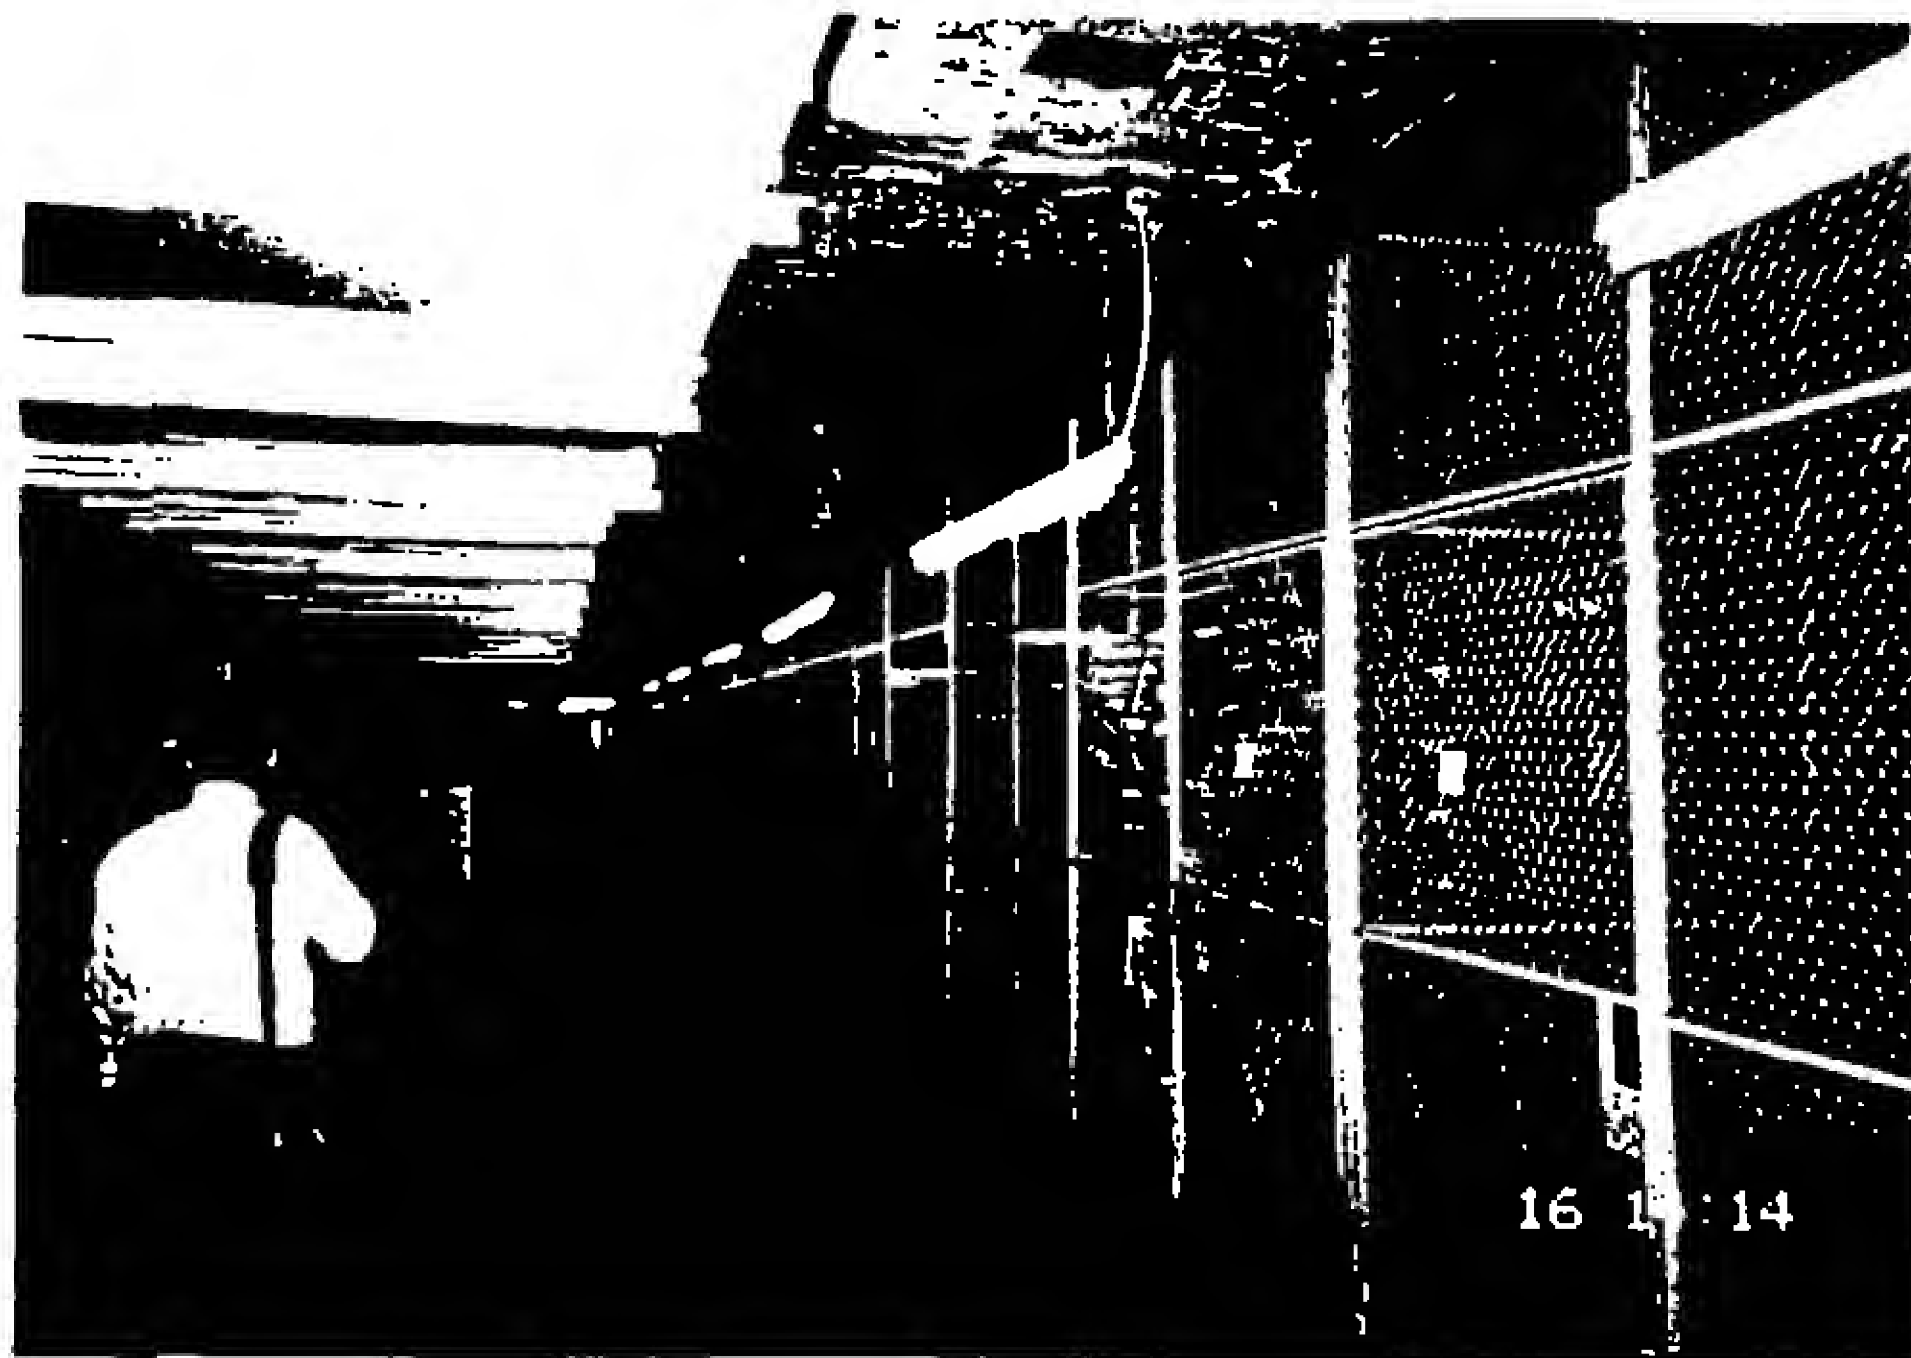
Photograph 23

B5 and B6 storage
spaces

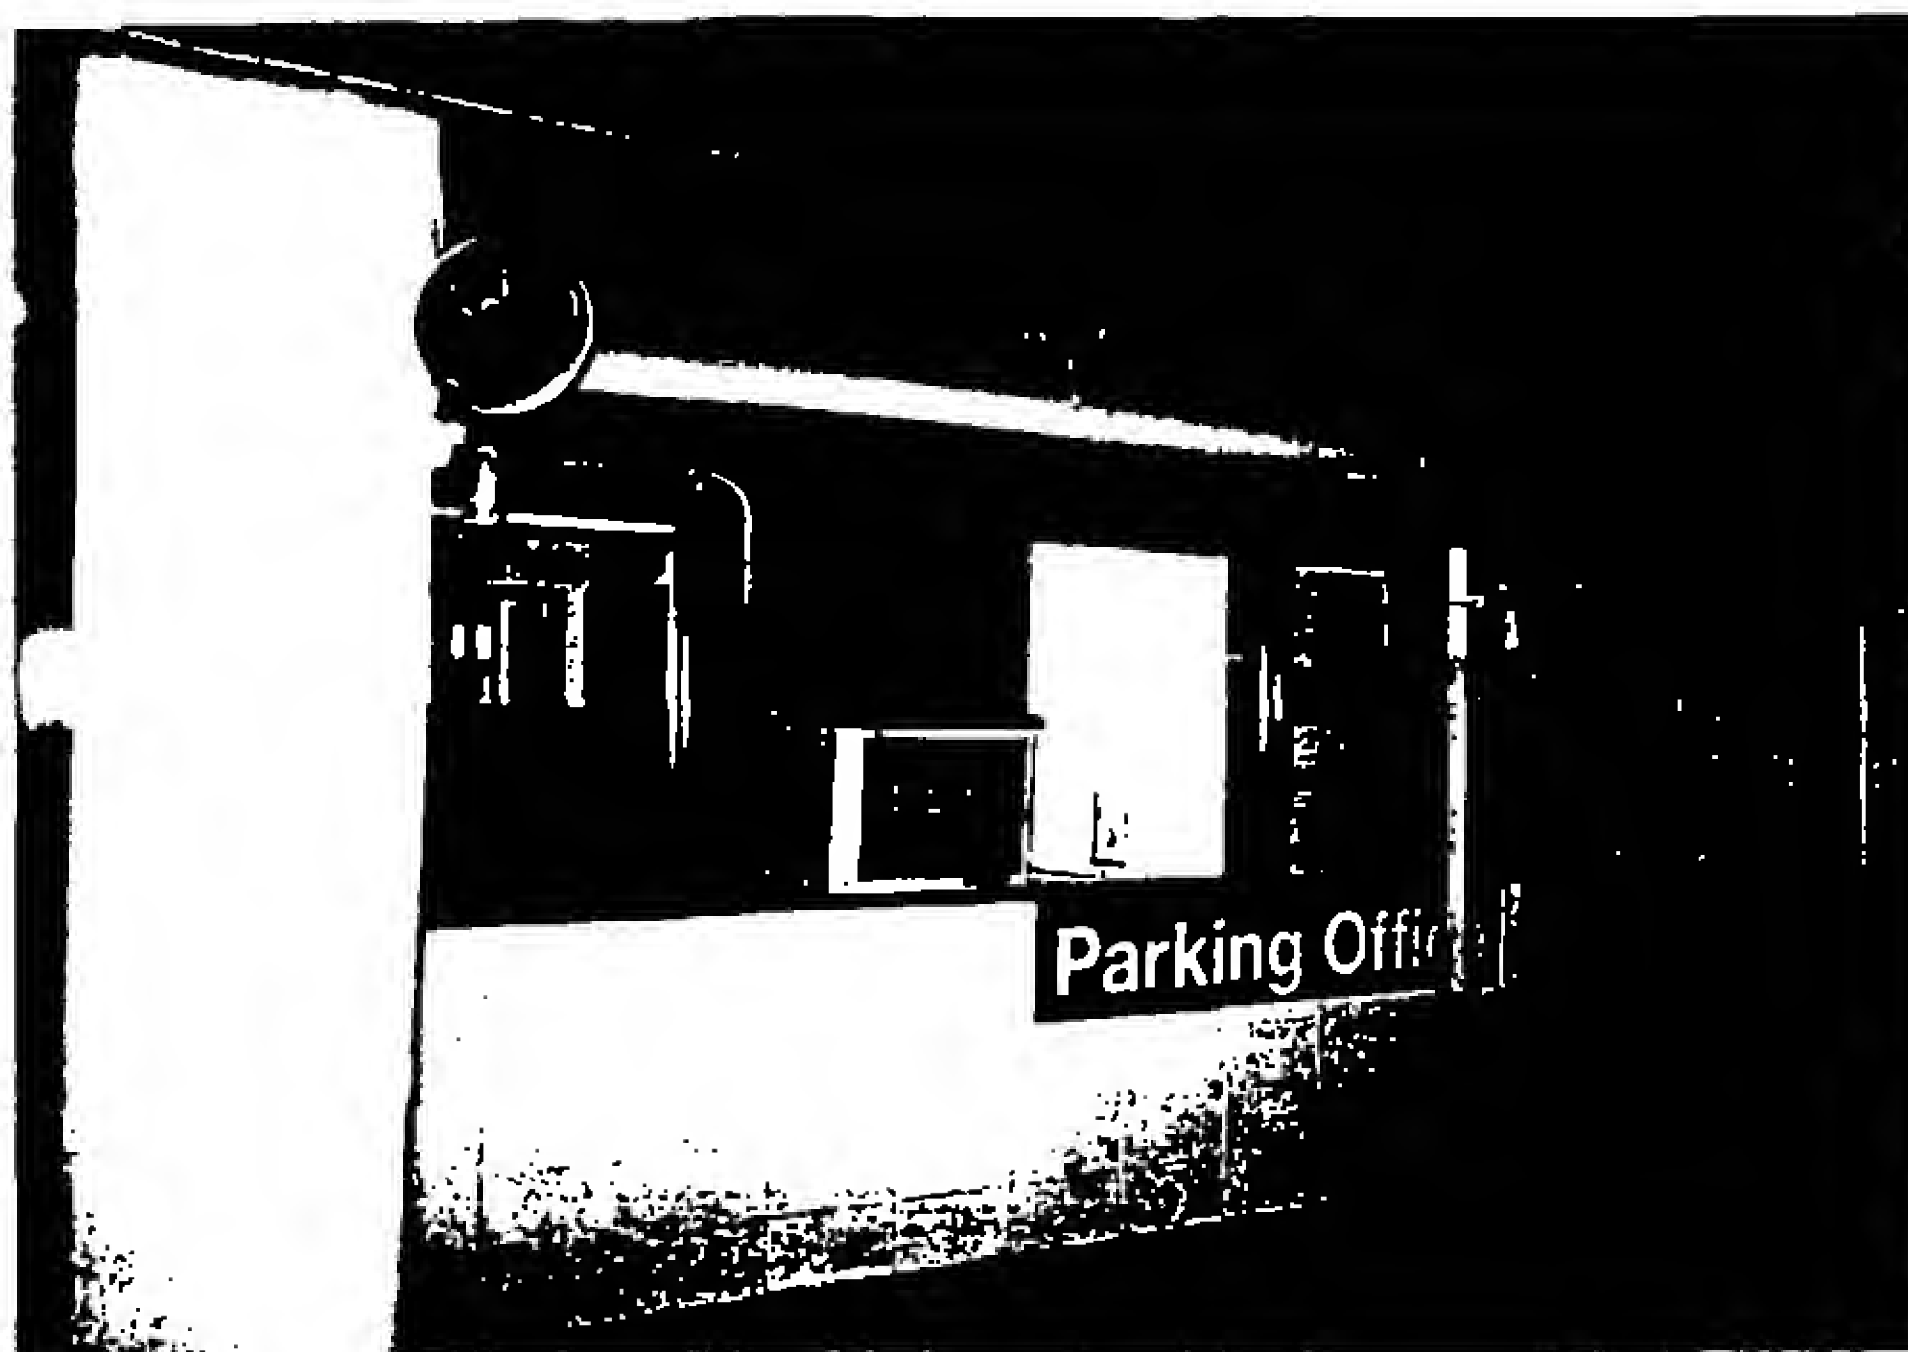
Photograph M2

Window style air
conditioning unit
used in the parking
office

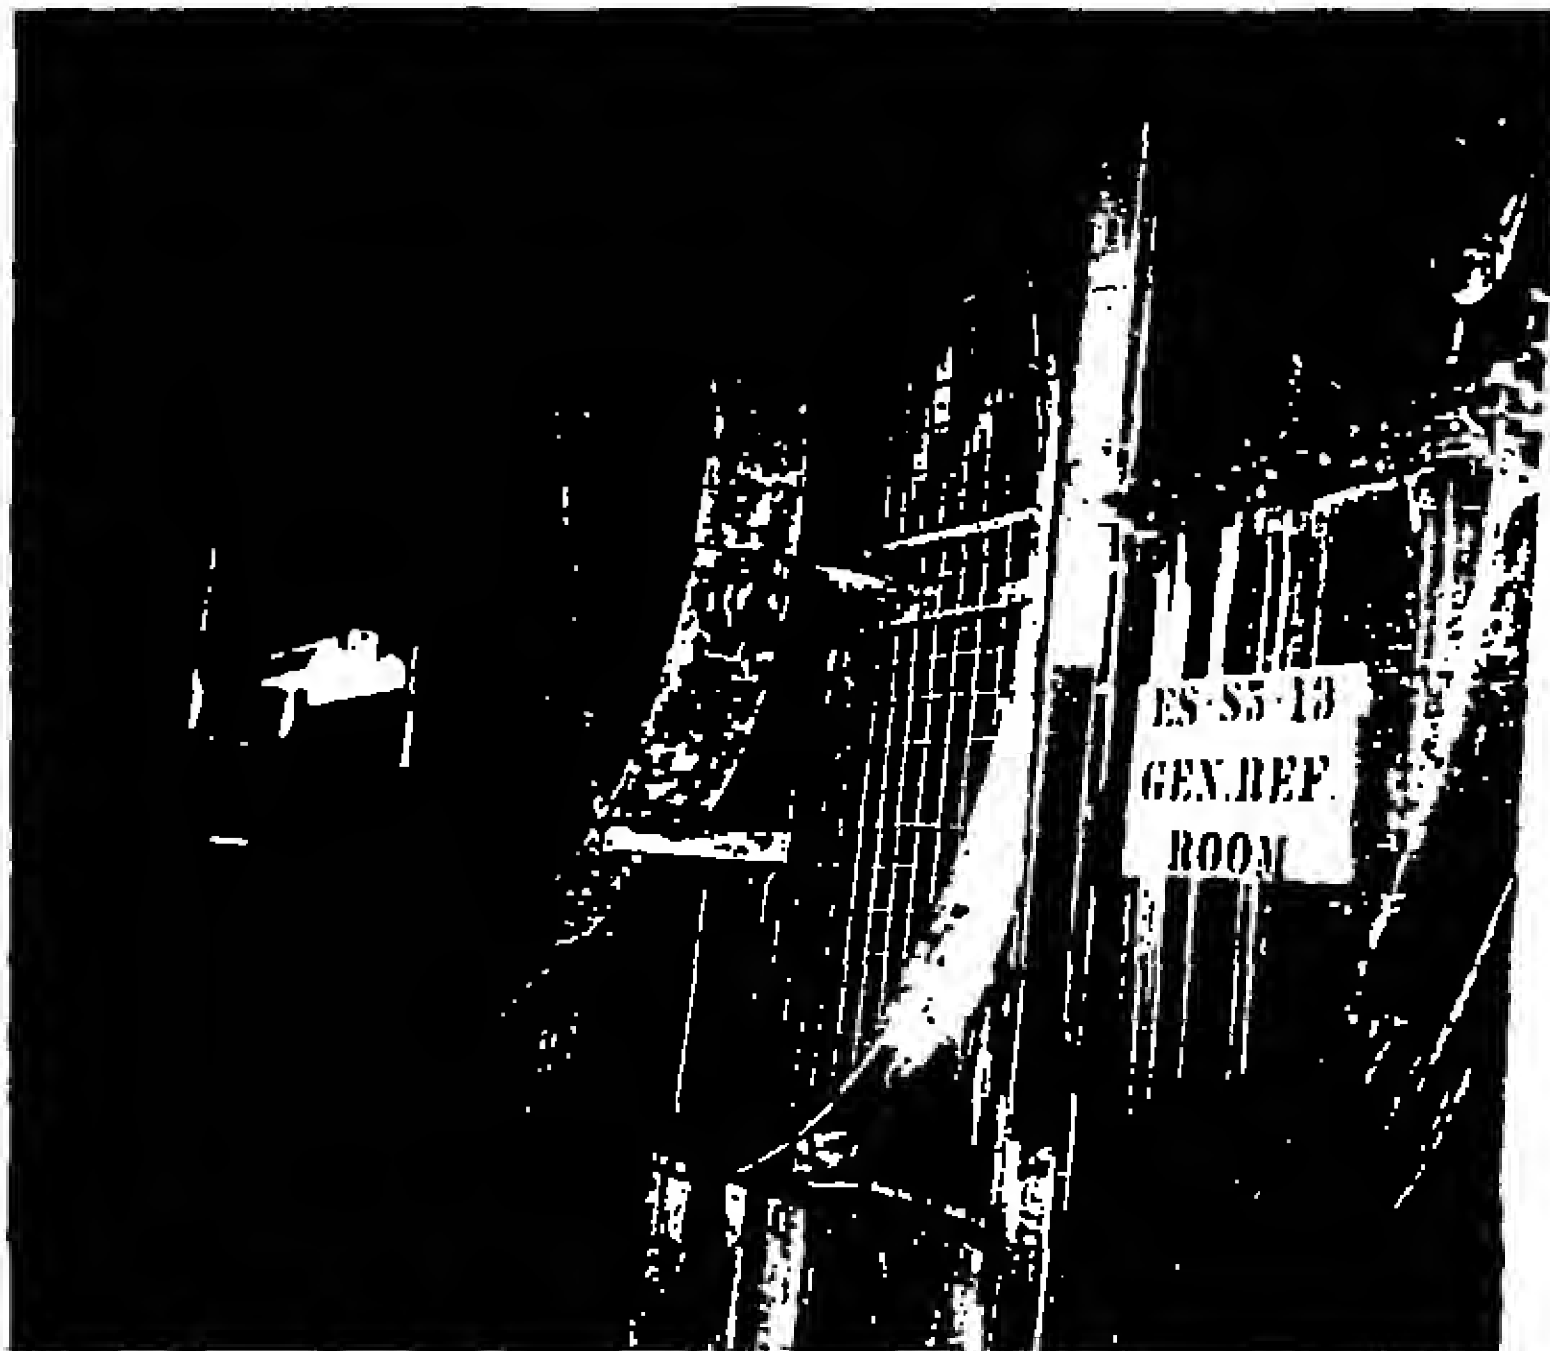
Photograph M5

Typical subgrade
exhaust fan
